Whirl Wind Propellers

SERVICE LETTER

SL-GA-J2B-012714

TO: ALL OWNERS / OPERATORS OF AFFECTED PROPELLERS
SUBJECT: BLADE CLAMP BOLT CRACK
DATE: JANUARY 27, 2014

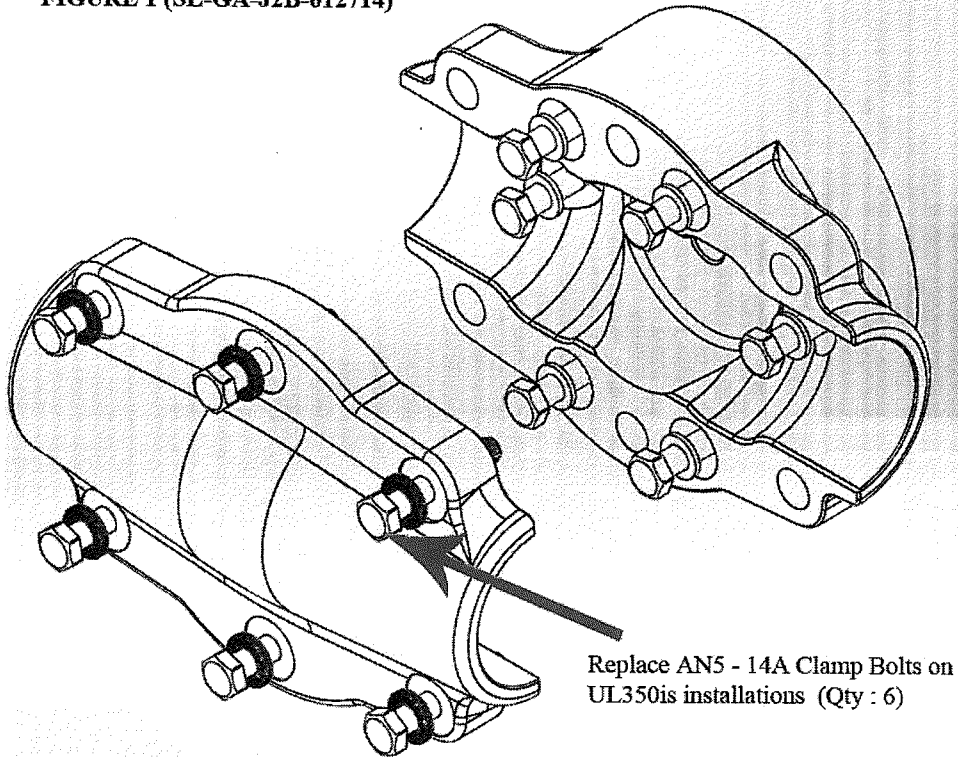
FIGURE 1 (SL-GA-J2B-012714)

REASON: Upon routine inspection of a **GA-J2B** propeller in the affected Serial Number range, installed on a UL350i engine, one of the propeller blade clamp bolts (AN5-15A) was found to have a crack. The propeller was installed on a UL-350i engine, with 65" diameter blades. The propeller had 300+ hours total time. The bolt crack found so far has been an isolated case.

Recommend replacement of all 6 hub clamp bolts (AN5-14A for UL350i installations) at time of every annual or every 100 hrs, whichever occurs first.

Affected propellers older than 1 year or with more than 100 hrs: Mandatory replacement of all 6 hub clamp bolts (AN5-14A for UL350i installations) before next flight.

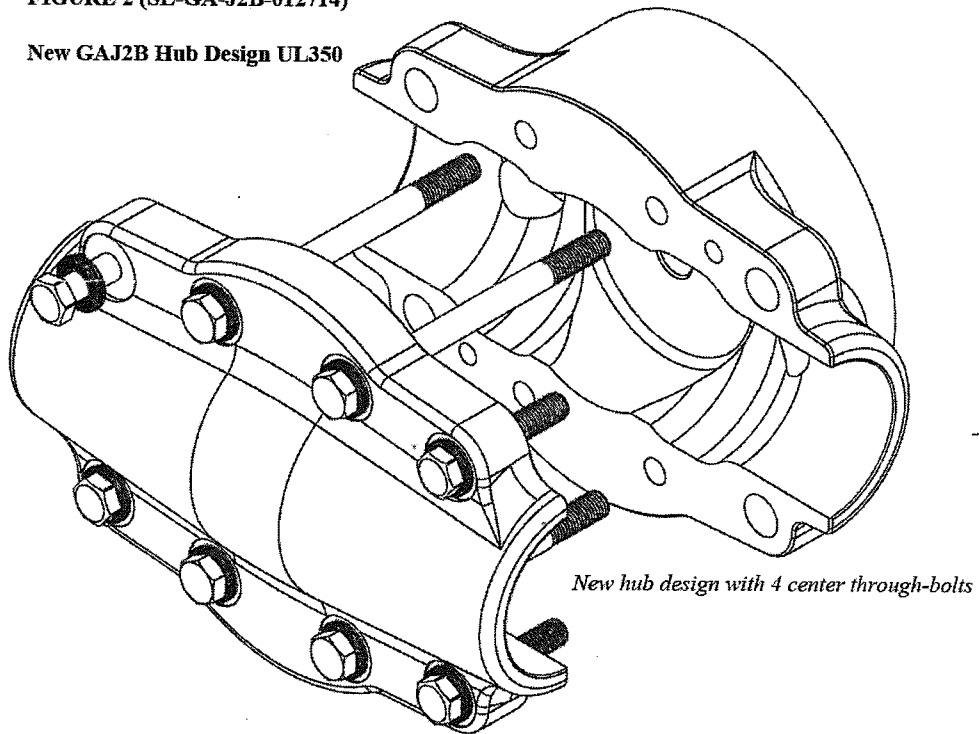
FIGURE 2 (SL-GA-J2B-012714)

New GAJ2B Hub Design UL350

Optional: Owners of affected propellers may trade-in affected propeller hub and purchase new style UL350 hub (See Figure 2) at reduced cost. Contact WhirlWind Propellers directly for pricing.
